## EASA Safety Information Bulletin

**SIB No.:** 2010-25  
**Issued:** 27 August 2010

**Subject:** **Cabin Oxygen Mask Service Recommendations from Original Equipment Manufacturers, and Cabin Oxygen Masks with B/E Aerospace In-line Flow Indicators Part Number (P/N) 118023-02.**

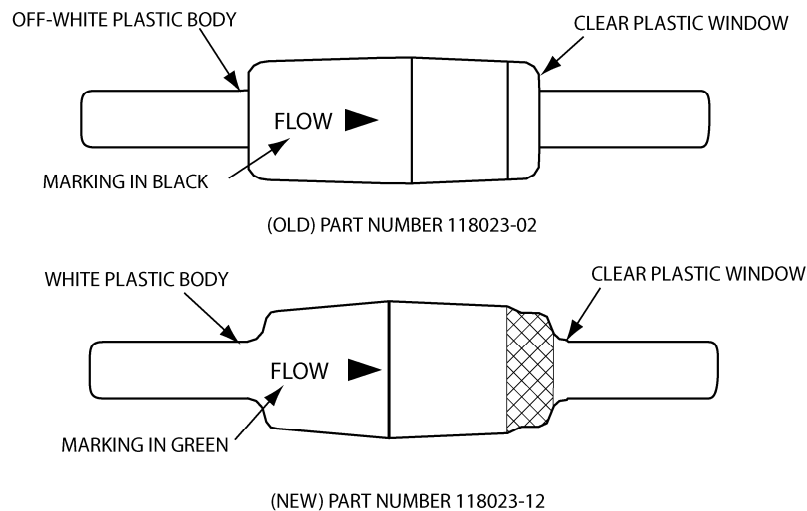
**Recommendations:** The first purpose of this SIB is to inform all aircraft owners, operators and maintenance companies that B/E Aerospace in-line flow indicators, part-number 118023-02, installed on B/E Aerospace oxygen masks that were manufactured on or after the 1<sup>st</sup> of January 2002 and before the 1<sup>st</sup> of March 2006 can be subject to failure and break loose.

When the in-line flow indicator breaks, no oxygen flows to the mask cup. The oxygen leaks out of the broken flow indicator, thereby putting the user at risk when supplemental oxygen is needed. To address this failure mode, B/E Aerospace developed a fix consisting of replacing the P/N 118023-02 in-line flow indicators with new ones of an improved design P/N 118023-12 (see fig.1 below).

**Figure 1** – How to distinguish B/E Aerospace in-line flow indicators P/N 118023-02 from -12

Until EASA and the FAA complete their review to determine if further AD actions are needed, EASA reminds all aircraft owners, operators and maintenance companies that complying with service recommendations as defined in B/E Aerospace Service Information Letter 174095-SIL-1 Rev.1, is a means to help the early detection of close-to-failure in-line flow indicators P/N 118023-02. These service recommendations also help ensure that certain life-limited elastomeric materials used in these mask assemblies are monitored and replaced upon condition with the
