**DIRECTORATE GENERAL OF CIVIL AERONAUTICS**  
**ACCIDENT PREVENTION DEPARTMENT**

OBJ: Sends a final report of the Investigation of the Aviation Accident, N°2052-24 (JIA) which determines the cause and issues recommendations.

REF.: Investigation of Aviation Accident No. 2052-24 (JIA).

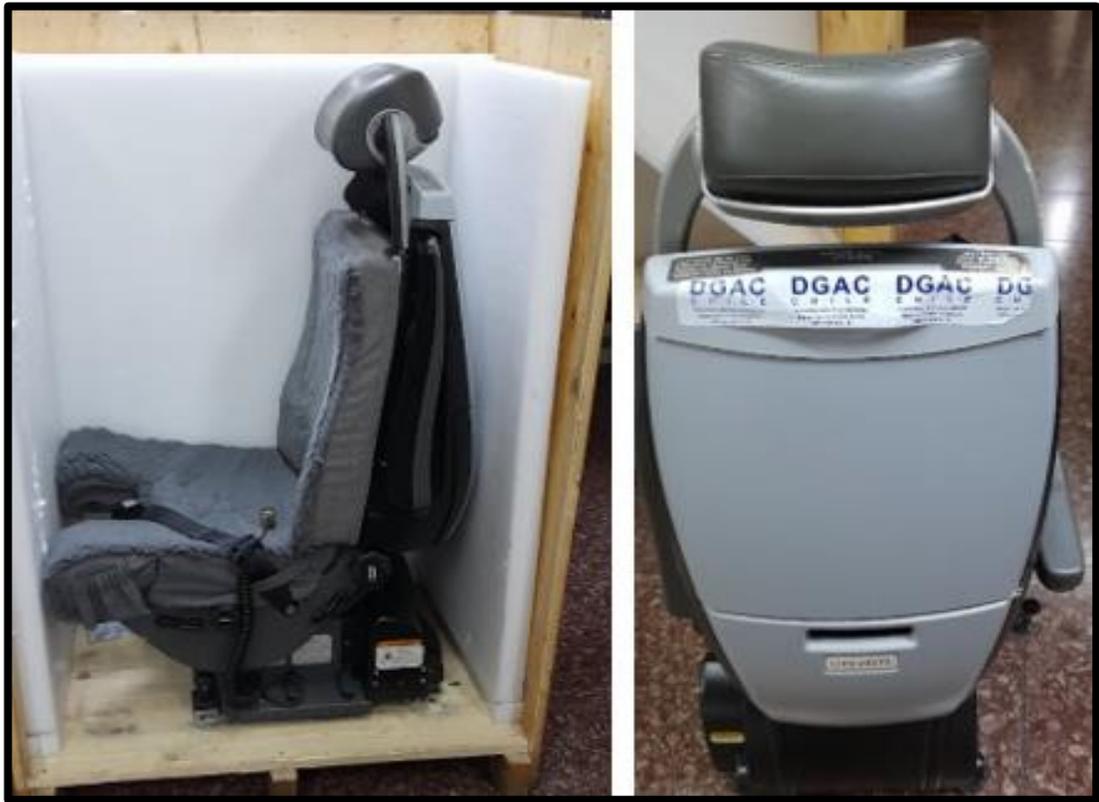
The integrity of the affected component and its data (SEAT ASSY CAPTAIN, SERIAL N°78592) was verified in DGAC facilities. After this verification, the DGAC security seals were installed.

Photograph N°2: Views of the Captain's seat.

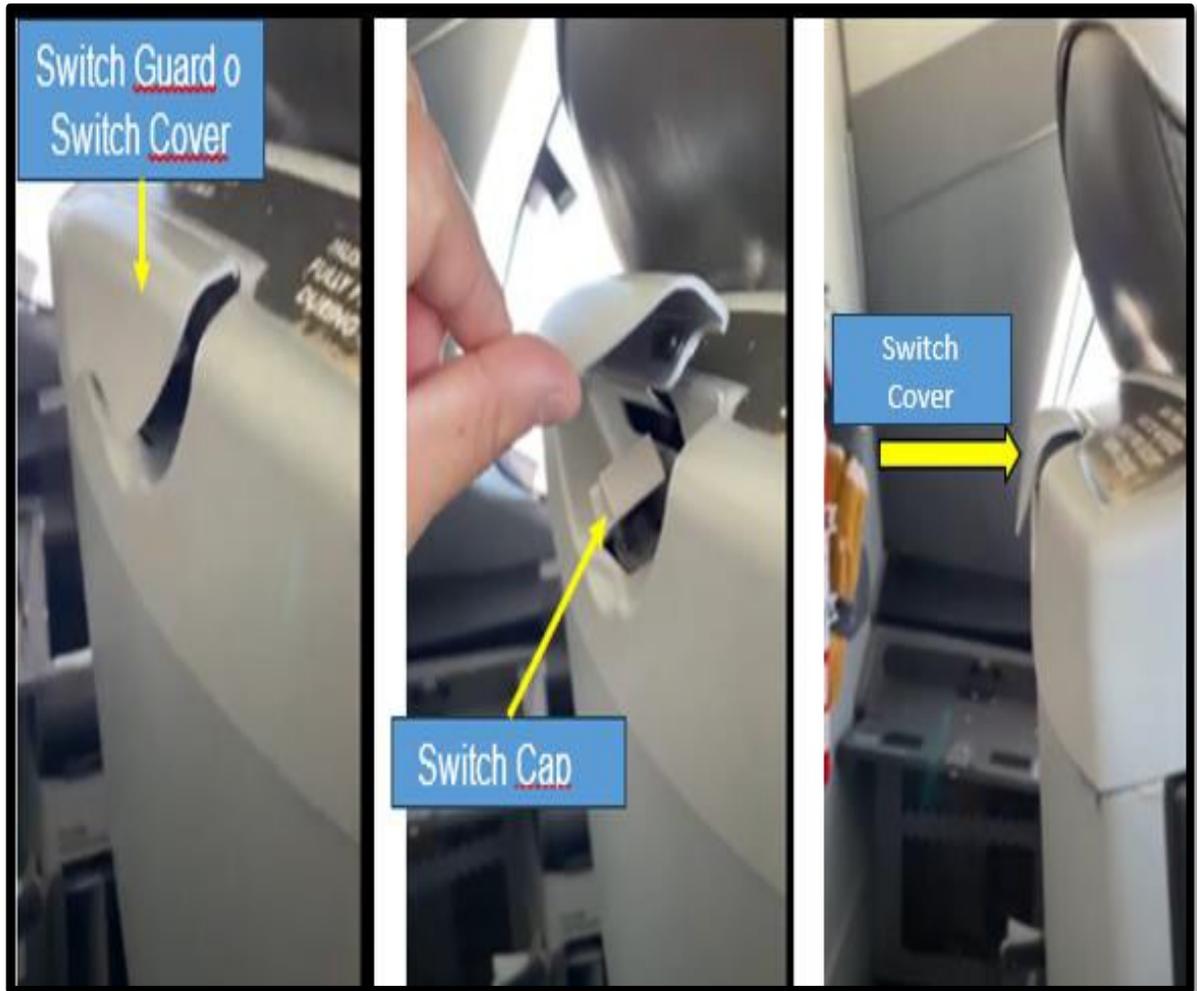
In this evidence, it was observed that the SWITCH GUARD, or SWITCH COVER that corresponds to the cover that covers the ROCKER SWITCH ASSEMBLY, did not remain in the closed and adjusted position. On the contrary, it was raised and supported on the SWITCH CAP, which, in turn, was displaced (detached), outside its fixing structure.

Additionally, it was found that when manually pressing the SWITCH COVER, the seat executed a forward movement. This action does not correspond to the normal operating procedure of the switch, according to photograph N°5.

Photograph N°5: Views of the condition of the SWITCH CAP and SWITCH COVER of the Captain's seat after the in-flight event.

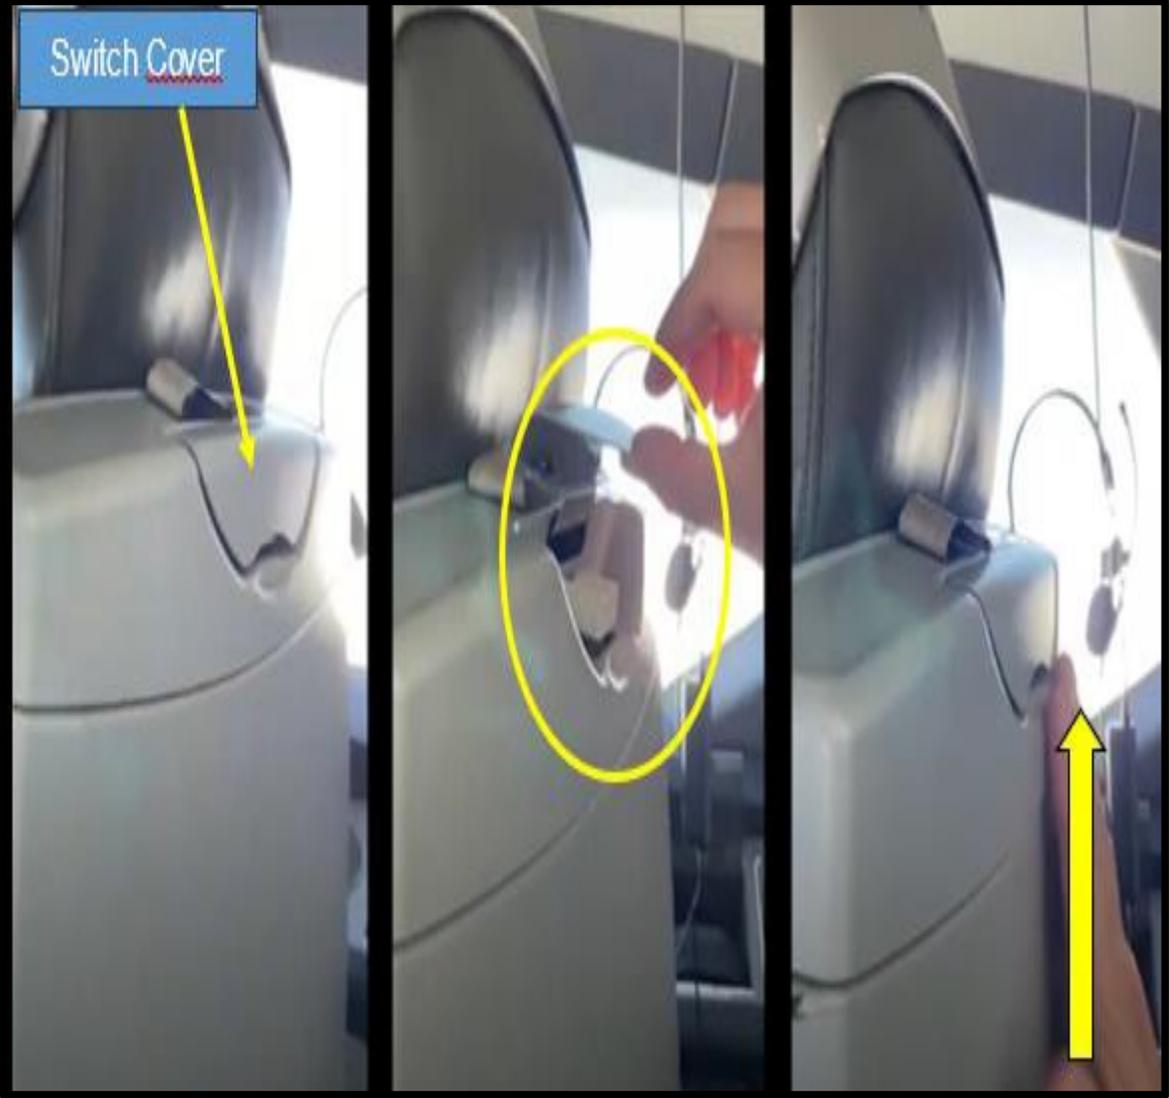
Subsequently, as a reference and comparison, photographs and videos were taken of the seat of the FIRST OFFICER'S SEAT (RIGHT), whose seat is located on the right side of the flight deck, where it was observed that the SWITCH COVER was in the closed position, adjusted, and was not resting on the SWITCH CAP.

In addition, it was observed that this SWITCH CAP was fixed to its fixing structure.

Photograph N°6: Views of the condition of the ROCKER SWITCH and SWITCH COVER of the First Officer's seat after the in-flight event.

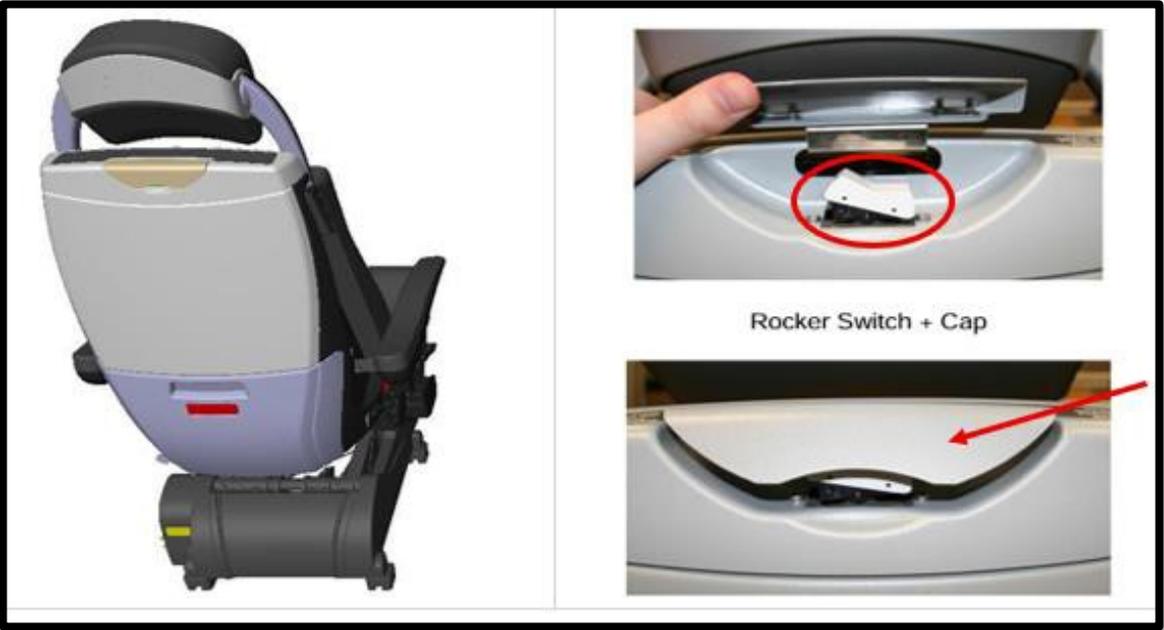
Photograph No. 13: Referential view of a seat, with the SWITCH CAP loose and the SWITCH COVER Lifted.

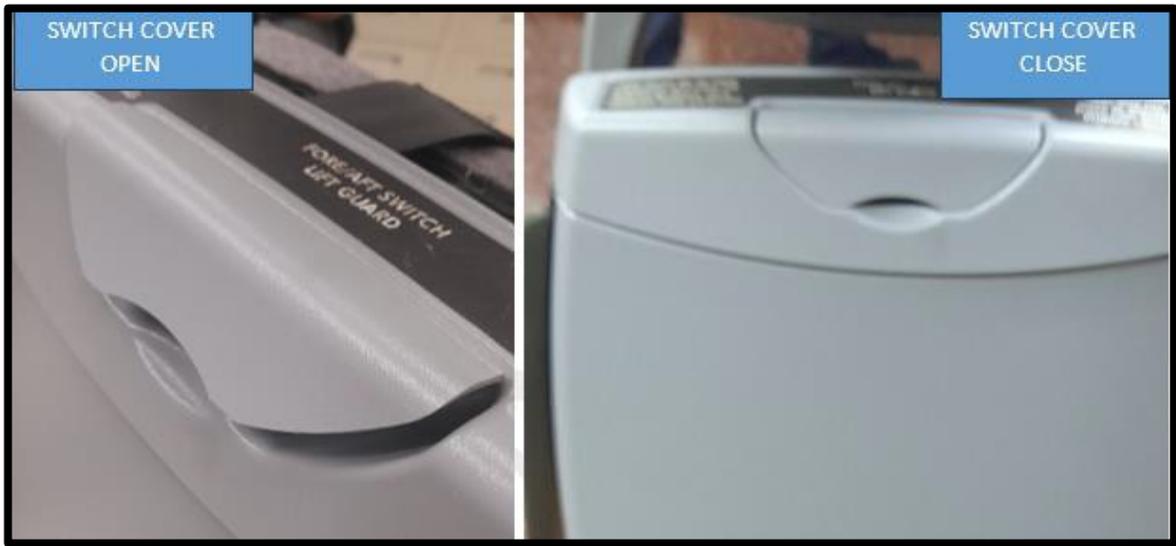
It was verified and verified that the SWITCH COVER (cover or cover), was not in the closed and adjusted position, which had already been observed in the videos and photographs that were previously taken of the Captain's seat.

The work team left the SWITCH COVER in the same position in which it would have been during the development of the flight of the event, according to photograph N°15.

Photograph N°15: Views of the SWITCH COVER in the open and closed positions, after the event.

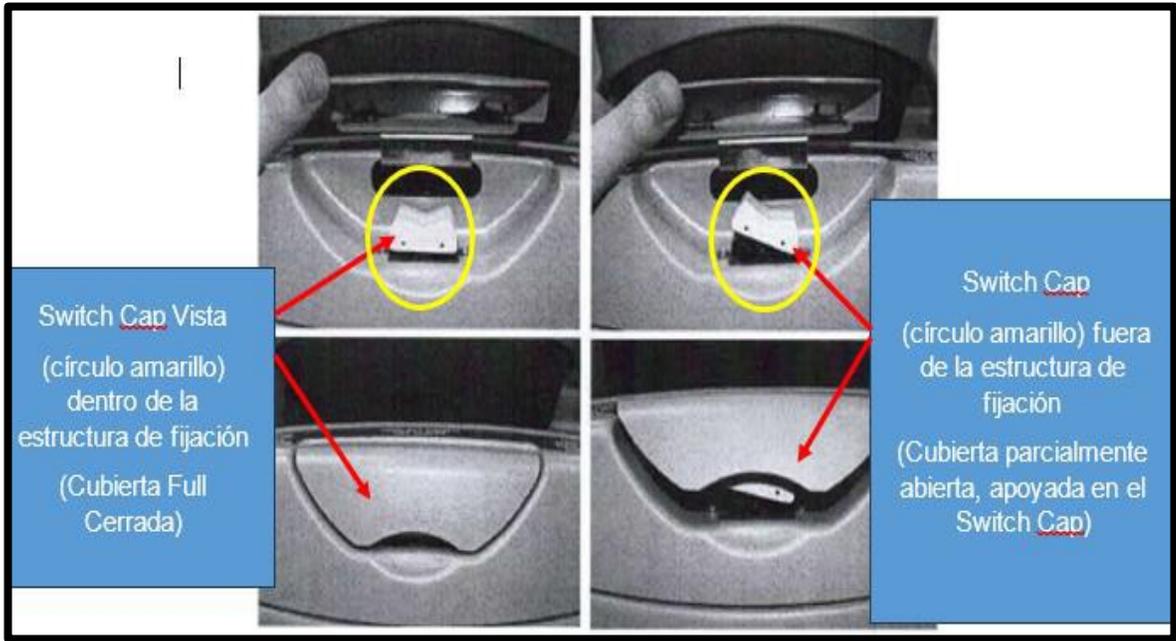
Then, it was verified that the position of the SWITCH COVER (cover or cover), in closed condition, was not possible to achieve, due to the position in which the SWITCH CAP was left as it was loose from its fixing structure, according to photographs N°16 and N°17.

Photo N°16: View of the ROCKER SWITCH Assembly during the inspection.

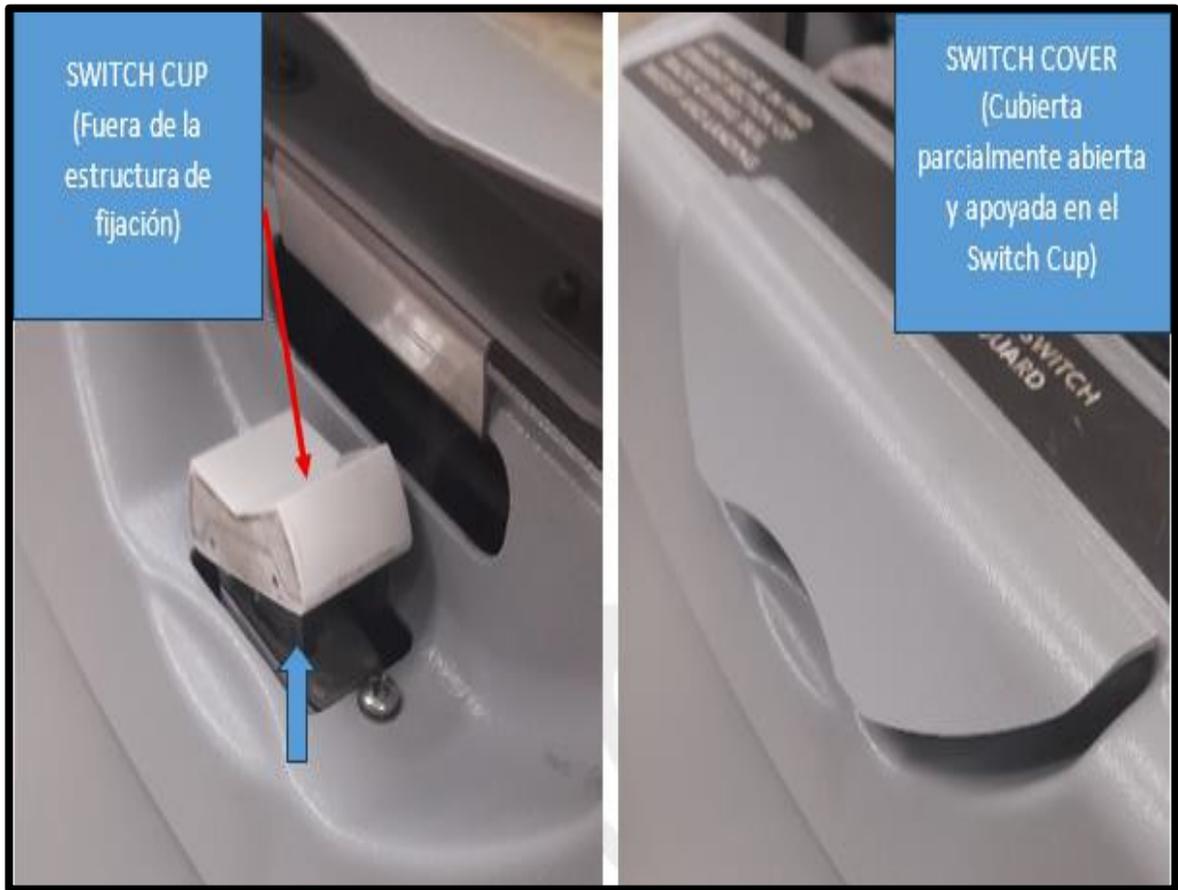
Photographs N°17: Views of the SWITCH CAP and SWITCH COVER.

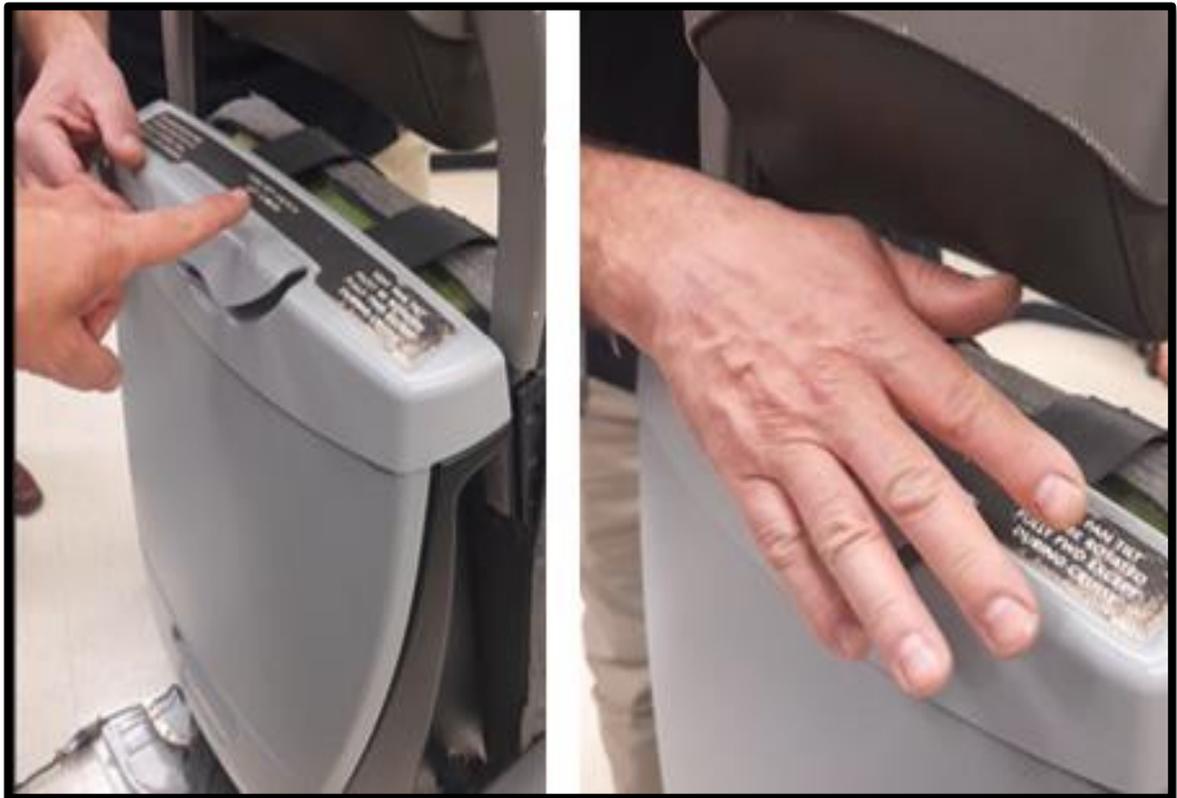
In accordance with the above, a test was carried out by pressing the raised SWITCH COVER, which immediately caused the seat to move forward. The test was carried out by pressing the SWITCH COVER with the whole hand and also with one finger.

The SWITCH COVER, the switch protector, is spring-loaded to keep the switch in the closed position. When he pressed it momentarily, bringing it to the closed position, he activated the switch of the CAP SWITCH since he pressed the rocker that was dislodged from its normal position, according to photograph No. 18.

Photograph N°18: Views of the pressure on the SWITCH COVER.

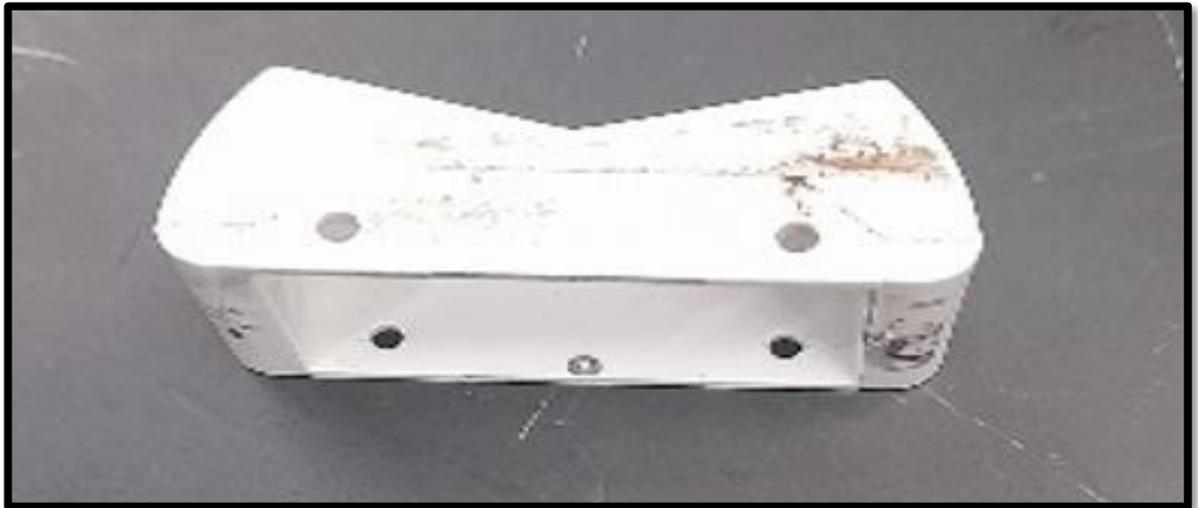
The SWITCH CAP was disassembled from the SEAT BACK FWD/AFT ROCKER SWITCH and inspected by Boeing specialists, evidencing the presence of multiple external surface fractures, which was sent to a laboratory of the aircraft construction company, for inspection, according to photograph No. 21.

Photograph N°21: Views of the affected SWITCH CUP.

Boeing also issued Service Letter SL-787-25-013 dated October 10, 2017, recommending operators incorporate the SB issued by IPECO.

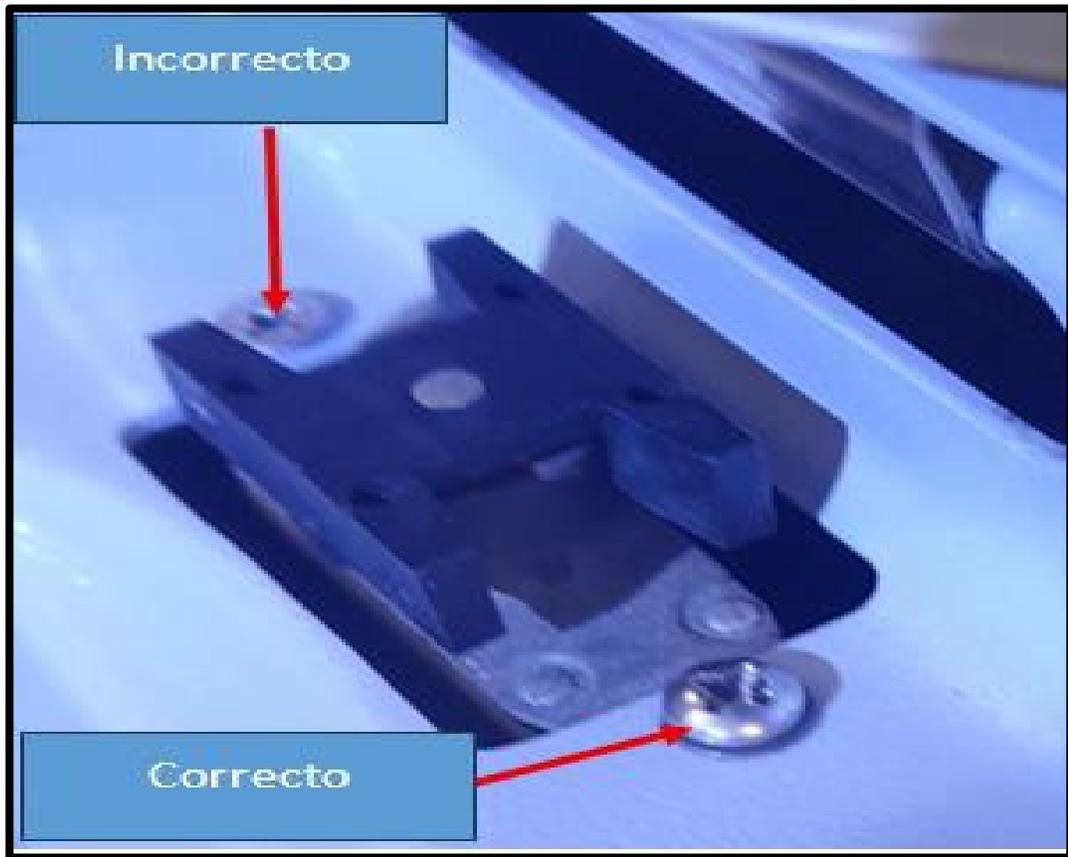
On the other hand, during the inspection in conjunction with the seat manufacturer, it was also found that the fastening structure of the SWITCH CAP, belonging to the Rocker Switch assembly, had a fastening element that did not correspond to the specification established in the corresponding parts catalog, Component Maintenance Manual (a different screw was installed), according to photograph No. 22.

Photograph N°22: Views of the support with different screws.

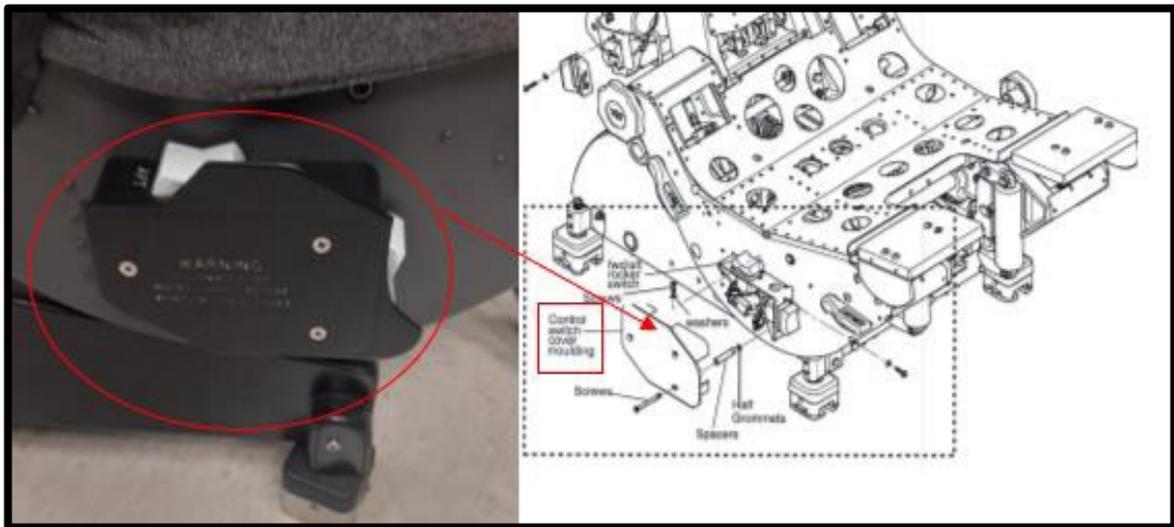
It was also observed that in the SWITCH COVER MOULDING Control, there was a cut that did not correspond to the original contour designed by the manufacturer, according to photograph No. 23.

Photograph N°23: Views of the SWITCH COVER MOULDING with a different cut to the manufacturer's design.

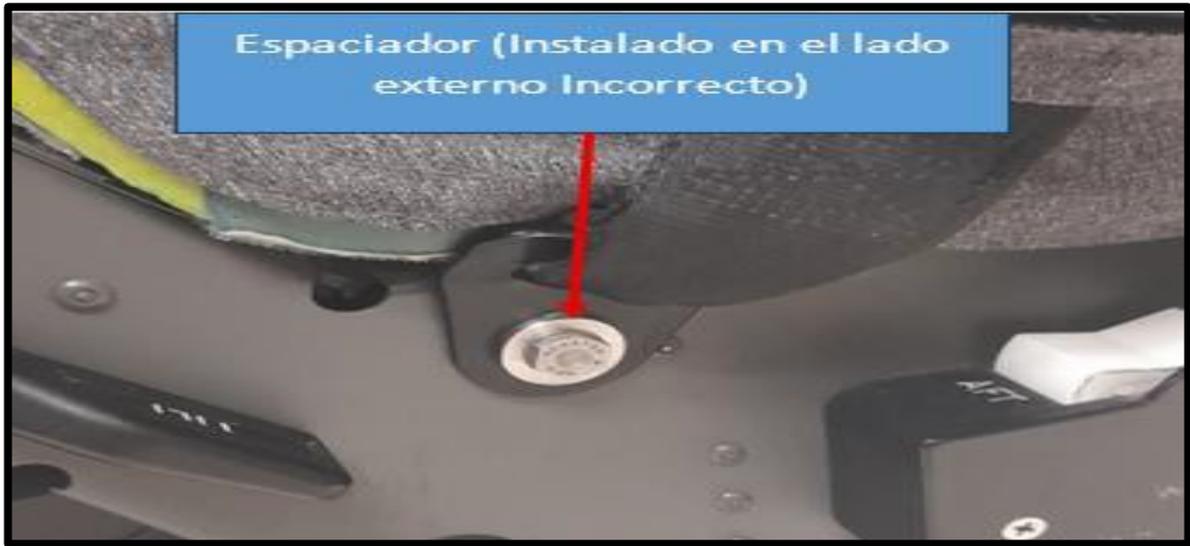
Similarly, it was verified that the spacers of the seat belts were not assembled according to the manual. The spacer must be installed on the inner side of the belt fastening and not as it was found and can be seen in photograph N°24.

Photograph N°24: View of the belt spacer, where it is installed on the external side, and must be installed on the internal side.

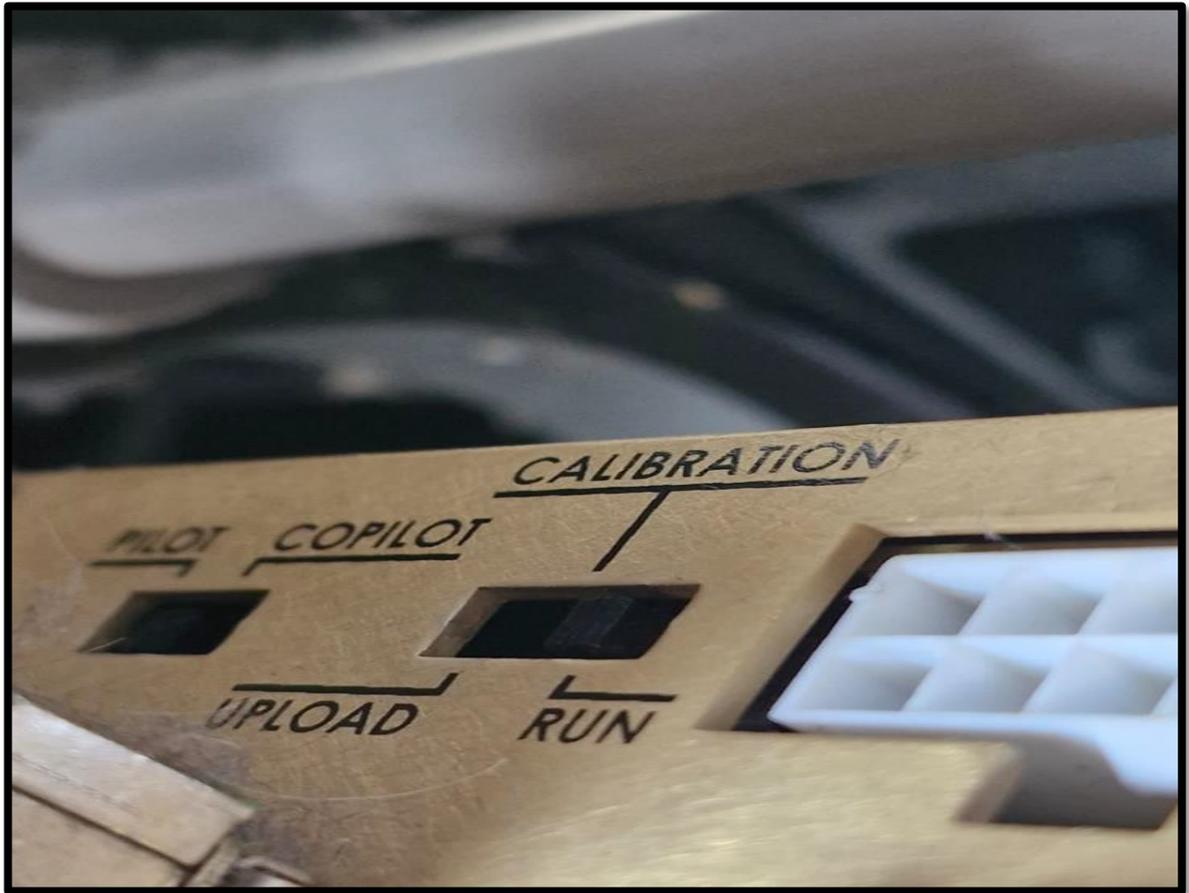
Photograph N°25.

Regarding the seat synchronizer, it was verified that it was in the "calibrated" position, instead of being in the normal position (RUN), as stipulated by the manufacturer. The procedimiento

established for this component indicates that after performing the calibration for the adjustment of the automatic stop of the end of travel of the seat movements, (from the different Switches), the synchronizer must remain in the RUN position, according to photograph N°25.

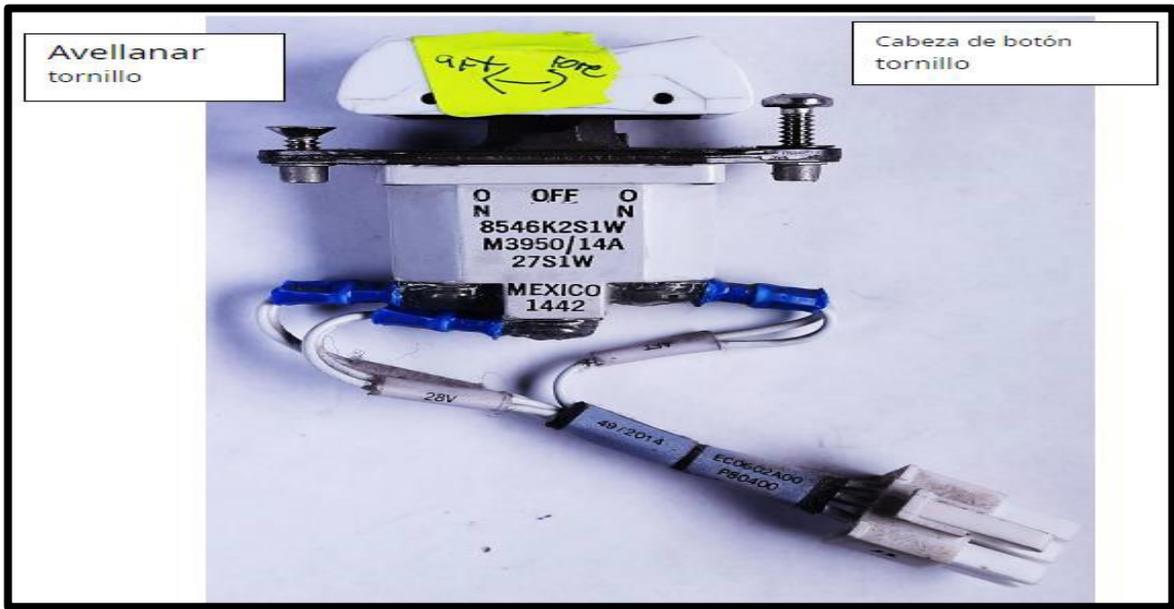
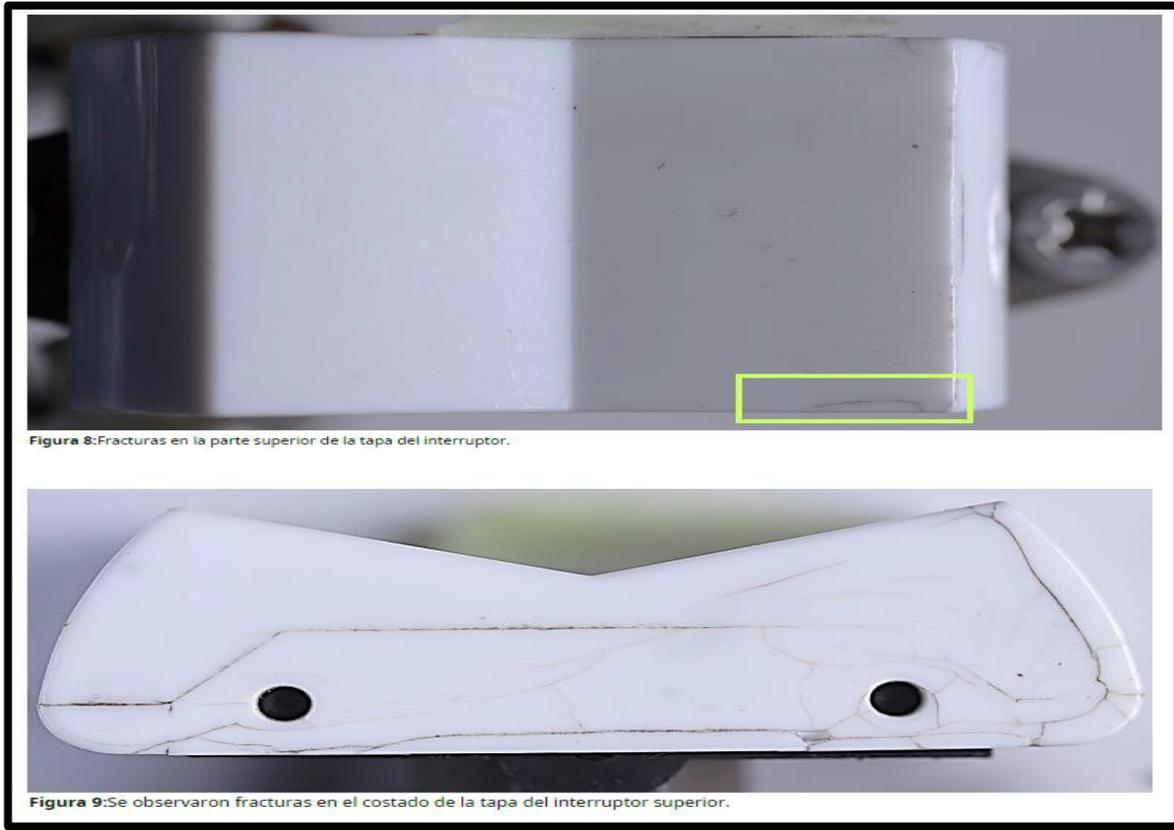
The two switches in question were visually examined under the supervision of the U.S. NTSB to assess their overall condition, focusing on the exterior, electrical connectors, wiring, rocker switch cover, and electrical terminals. Computed tomography (CT) scan was performed on both switches to examine the internal subcomponents and mechanical connection for apparent damage, excessive material wear, foreign object debris (FOD), or other anomalous features, as per photographs No. 26 and No. 27.

No notable findings were observed in the electrical terminals, connector, wiring, or switch body.

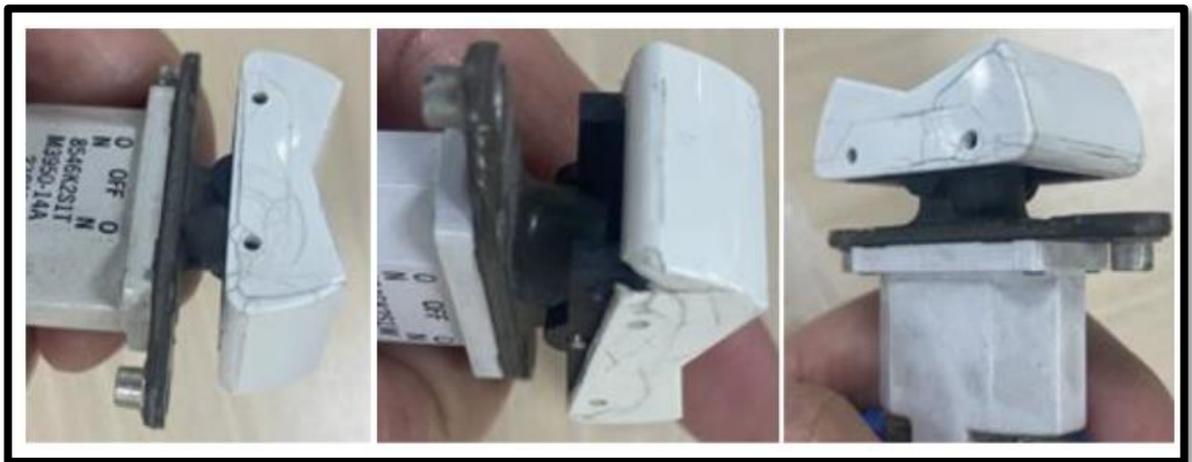
Photography N°28

Inspections have shown that even after modification, the switches continue to exhibit the same type of damage that prompted the issuance of FAA AD 2024-16-14.

22 out-of-service switches were sent for analysis to the address provided by Boeing.
