SPECIAL AIRWORTHINESS **INFORMATION BULLETIN**

SUBJ: ELEVATOR TORQUE TUBE – Inspections for cracks and corrosion SAIB: CE-17-25 in elevator torque tubes Date: August 25, 2017

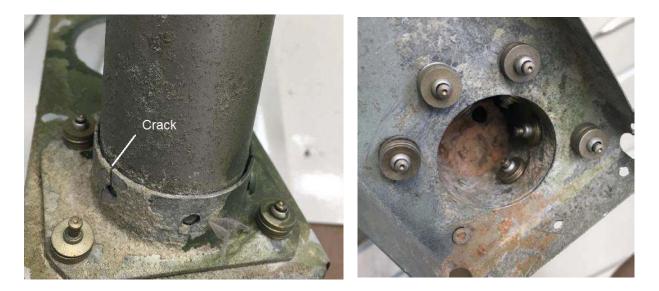
The elevator torque tube pictured below was removed from a Cessna Model 172C airplane during an annual inspection for cracks, corrosion and improper repairs. The airplane had spent 24 years in Florida (a high corrosion area). During the annual inspection, a blind rivet installation (not approved) was found. The date of this blind rivet installation could not be determined.

These elevator torque tubes have been installed on Cessna 100 airplanes since the 1950s and continue to be installed on production Cessna 172 and 182 airplanes. The tubes are made of aluminum. They are exposed to wheel spray during landings or spray from floats during water landings. The tube is oriented horizontally so it tends to retain water. Exposure to moisture over many years leads to corrosion damage. Airplanes used in coastal areas are especially prone to corrosion.

For Cessna 100 airplanes and Cessna 208/208B airplanes, we recommend adherence to the applicable Textron Aviation SIDs and maintenance manuals for corrosion inspections. Airplanes based or operated in high corrosion areas are recommended to be inspected more frequently. Pilots should check this area for corrosion or obvious damage during preflight inspections. If minor surface corrosion is found, remove the corrosion in accordance with Textron Aviation procedures. If cracks or severe corrosion is found, replace the affected parts.
