**DIRECTORATE GENERAL OF CIVIL AERONAUTICS**  
**ACCIDENT PREVENTION DEPARTMENT**

OBJ: Sends a final report of the Investigation of the Aviation Accident, N°2052-24 (JIA) which determines the cause and issues recommendations.

REF.: Investigation of Aviation Accident No. 2052-24 (JIA).

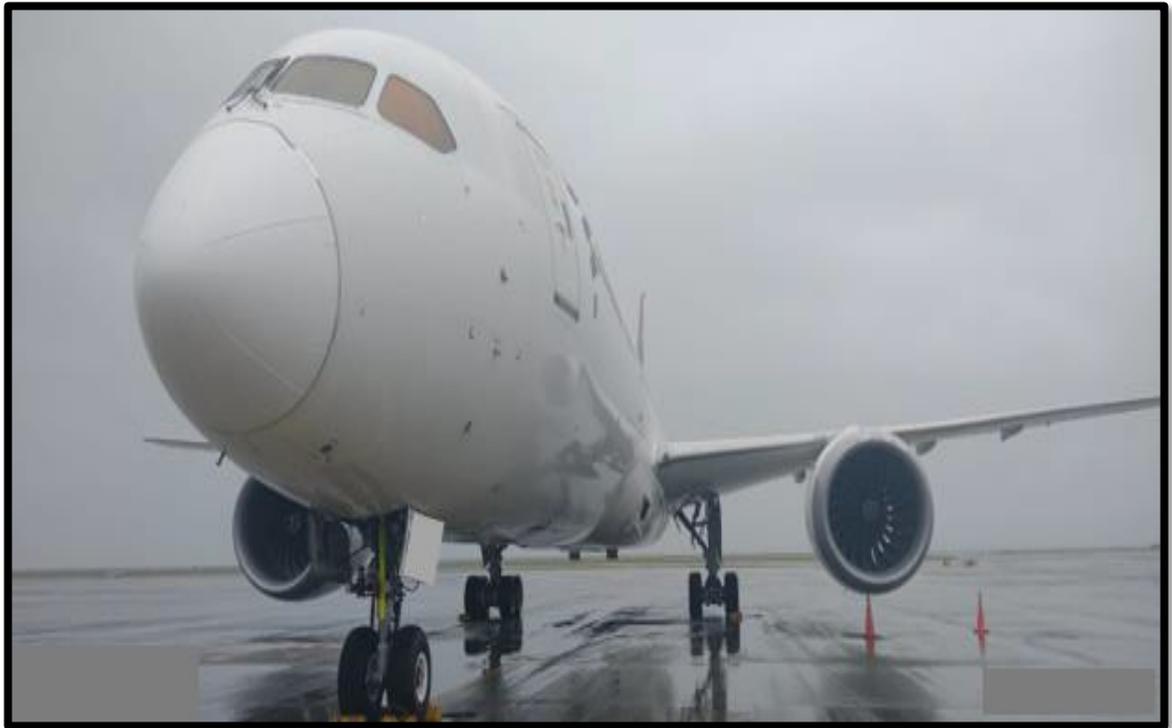
Photograph N°1

At Auckland International Airport (NZAA), New Zealand, the investigative team, with the support and presence of the Maintenance Line Manager (CMA) and the head of the operating company's office, carried out an internal and external inspection of the aircraft involved, (Boeing model 787-9), which was in a remote parking lot of the Airport. according to photograph N°1.

It was verified that the damage suffered by the aircraft as a result of the event was limited exclusively to the main cabin and the flight deck.

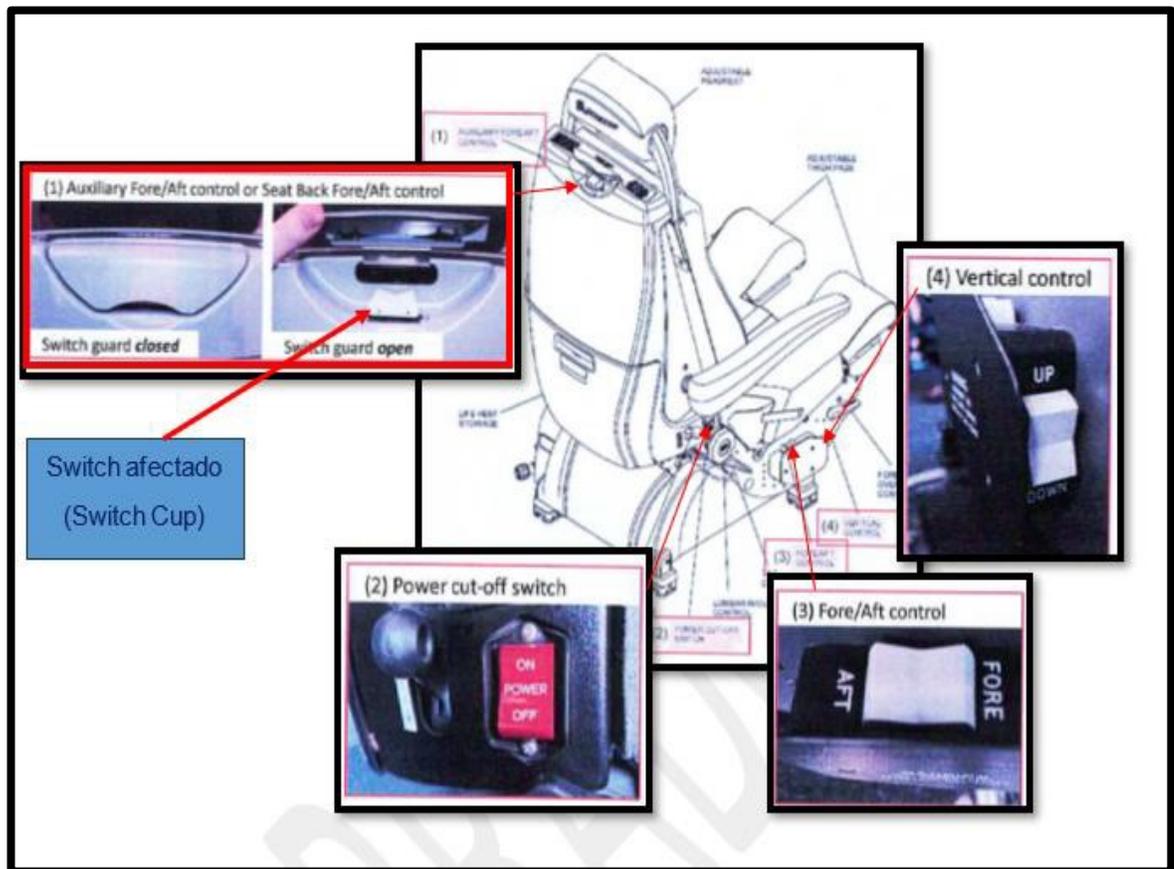
Photograph N°7

There are four switches to control the movements of the seat (manufactured by IPECO HOLDINGS LTD.) according to photograph N°7.

It should be noted that the three white switches (the backrest forward/reverse control and the forward/reverse and vertical controls on the side of the seat) are momentary action switches that automatically return to the off state when released. The red switch is an alternating action switch that stays in the on or off position when released.

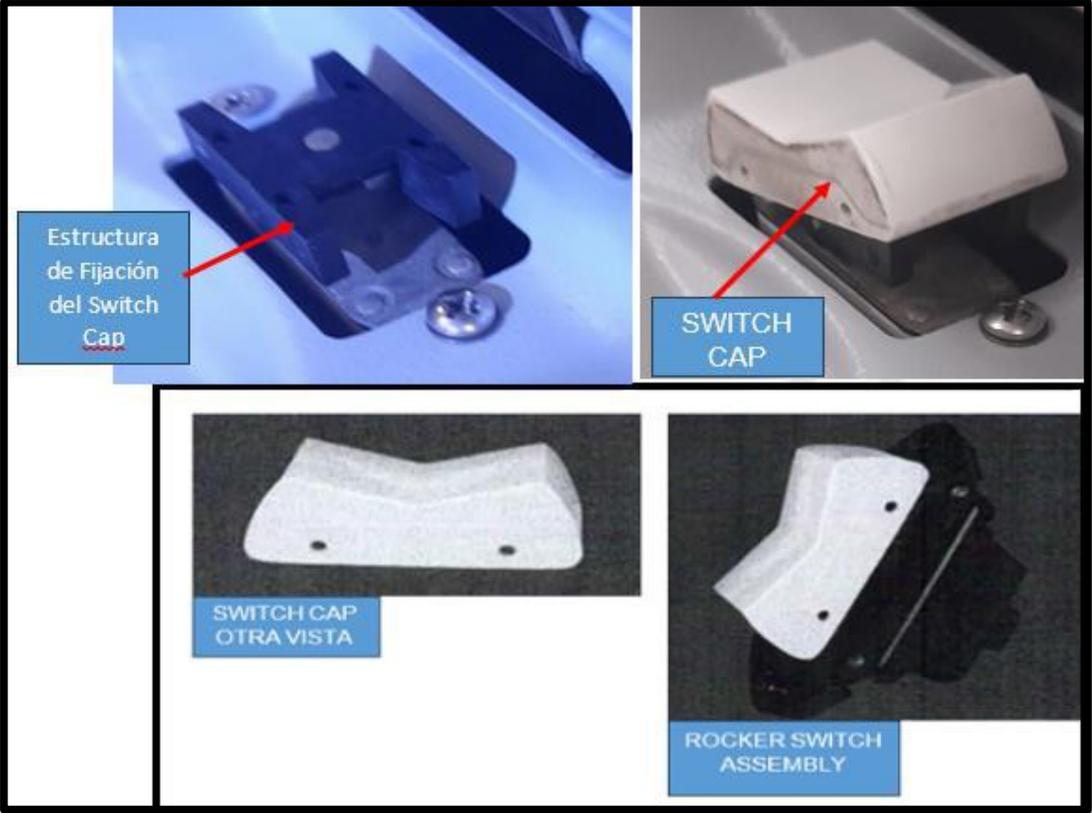
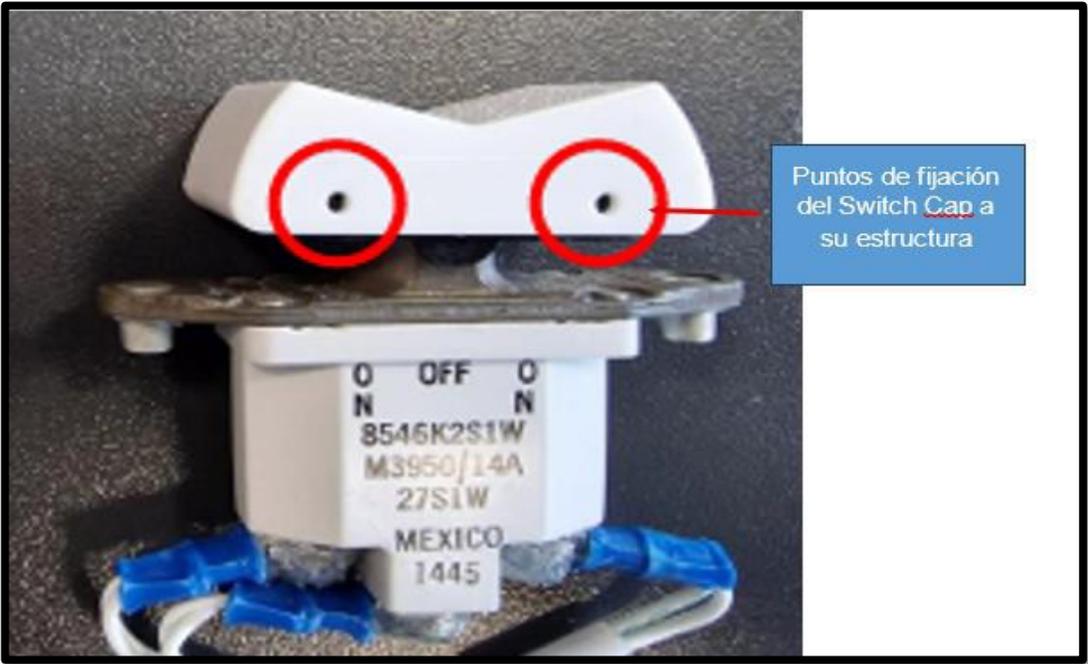
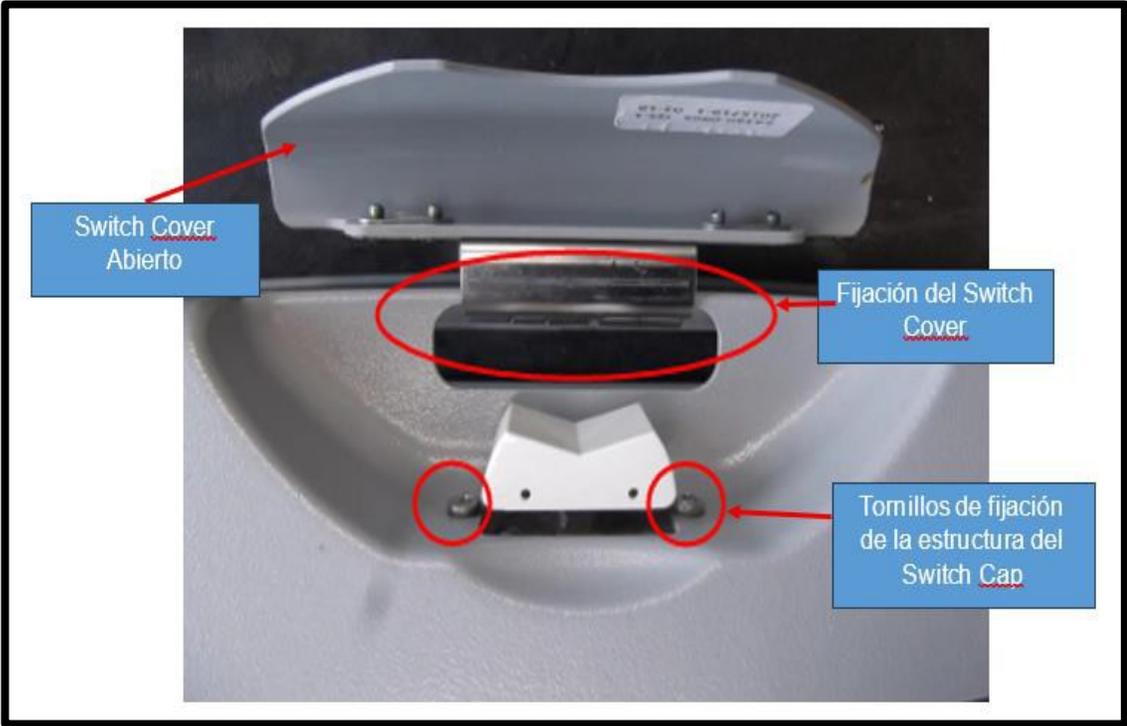
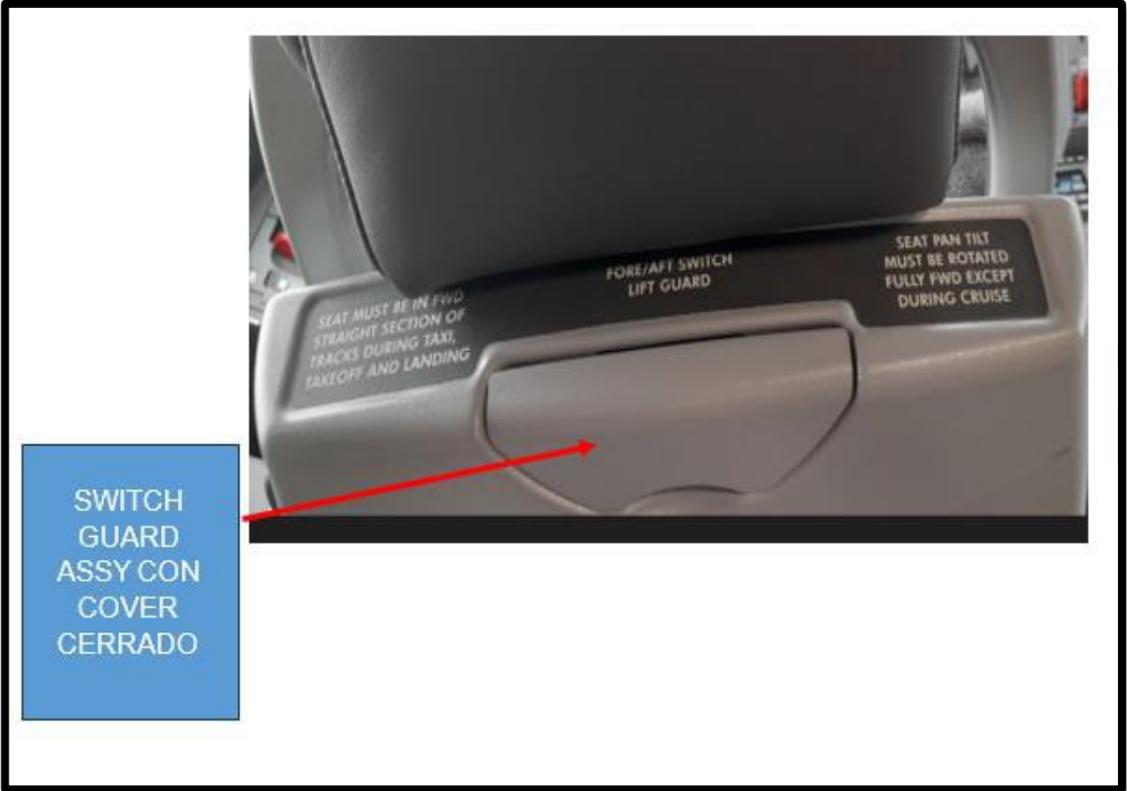
The switch guard (lid) on the seat back is spring-loaded in the closed position to prevent unintentional operation of the switch.

The set of these components is shown and described below, according to photographs N°8, N°9, N°10 and N°11.

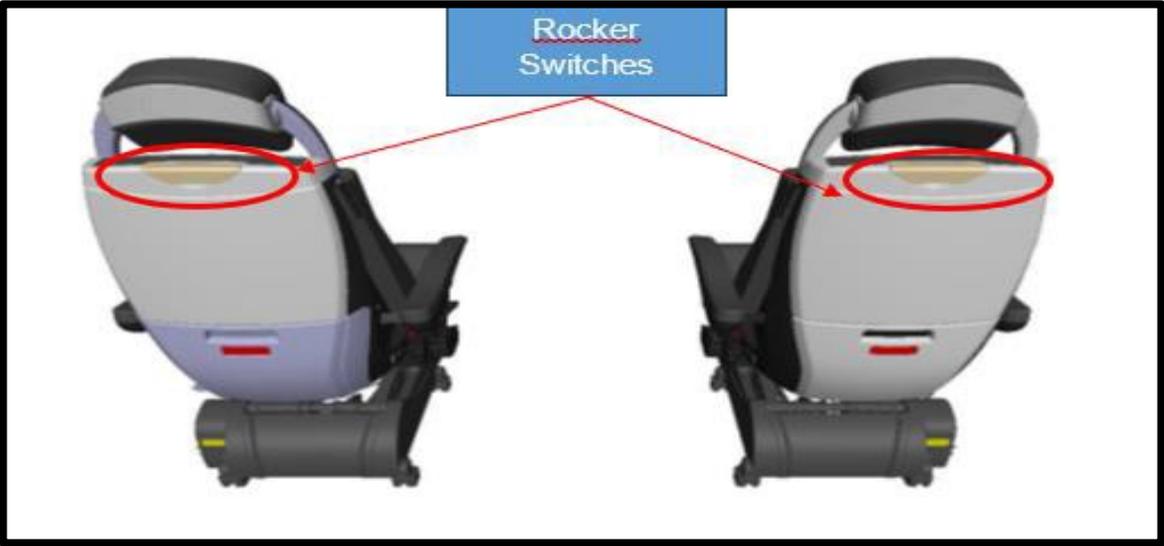
For a better description of the location of both SEAT BACK FORE / AFT CONTROL SWITCH (ROCKER SWITCHES), in the Captain's and First Officer's seats, which are located on the flight deck, a view from behind is shown in the following photograph, where you can see the place where they are installed according to photographs No. 12 and No. 13.

Photograph No. 12: View of the Captain's and First Officer's seats.

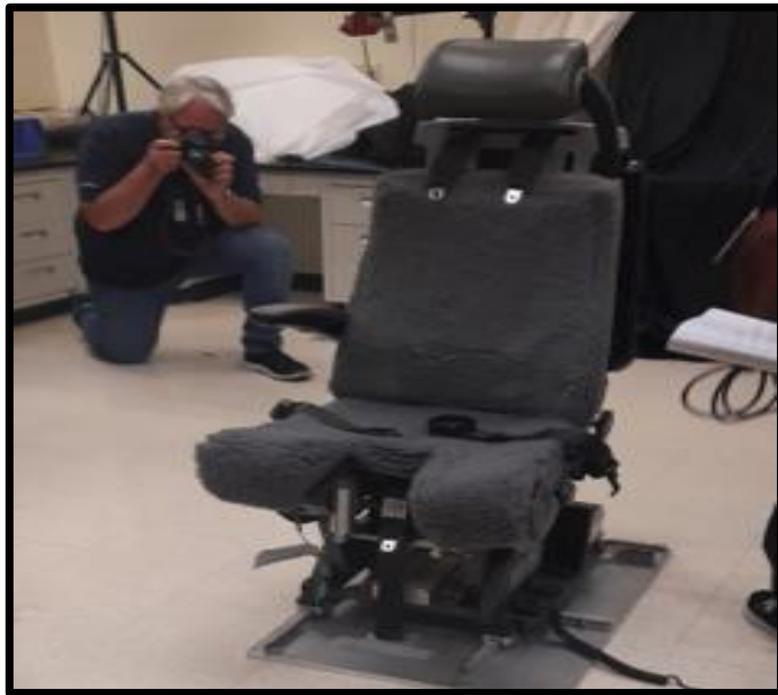
The seat was mounted on a test rail and electrically energized to allow functional operation, according to photograph N°14.

Photograph No. 14: View of the seat on the inspection rail.

It was verified and verified that the SWITCH COVER (cover or cover), was not in the closed and adjusted position, which had already been observed in the videos and photographs that were previously taken of the Captain's seat.

In accordance with the above, a test was carried out by pressing the raised SWITCH COVER, which immediately caused the seat to move forward. The test was carried out by pressing the SWITCH COVER with the whole hand and also with one finger.

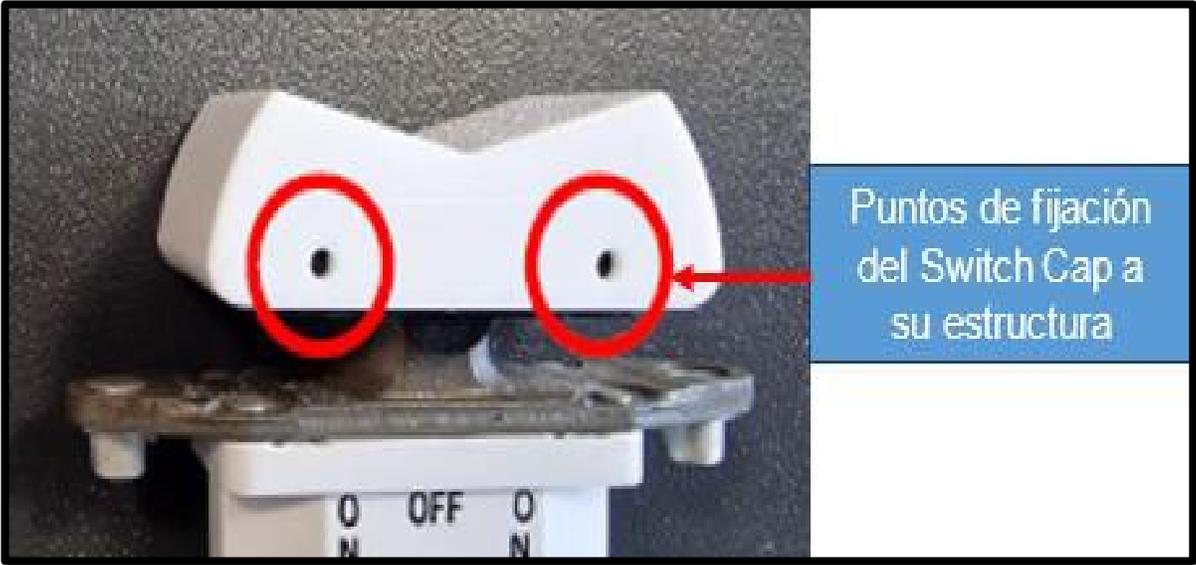
This component is a part of the seat structure (Base Switch), whose mounting feature is in the shape of an "H" or the material of the "SUB-BUTTON" which is a resin thermoplastic filled with glass.

The other detachable part in white, identified as a rocker button or ROCKER SWITCH CAP, according to photographs N°19 and N°20.

Photograph N°19: Views of the SWITCH CUP and its attachment points.

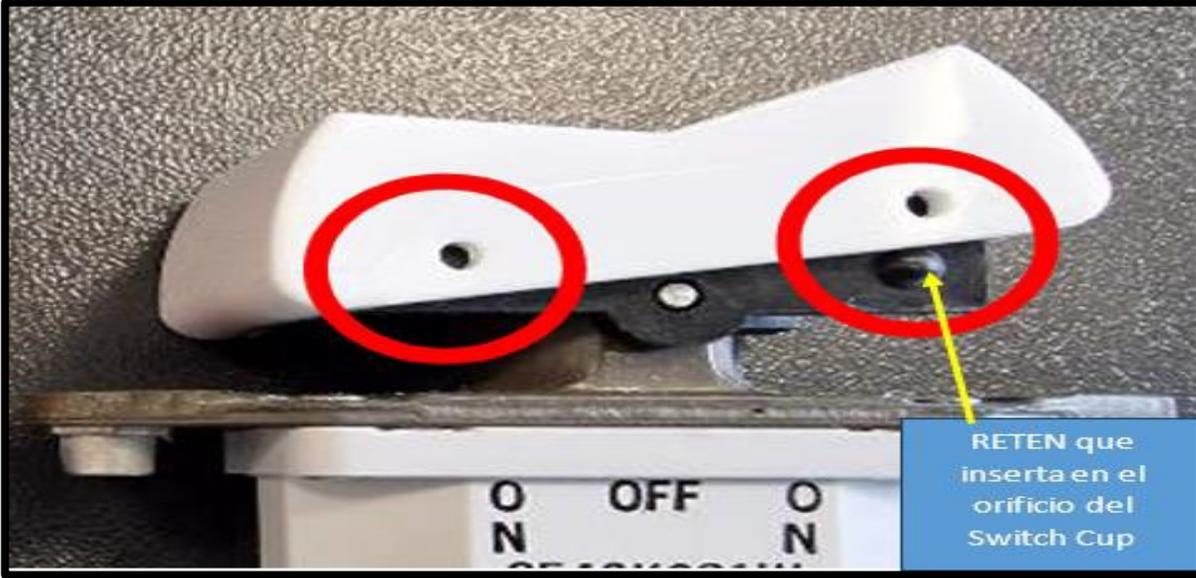
Photo No. 20: Views of the SWITCH CUP and its attachment points.

The SWITCH CAP was disassembled from the SEAT BACK FWD/AFT ROCKER SWITCH and inspected by Boeing specialists, evidencing the presence of multiple external surface fractures, which was sent to a laboratory of the aircraft construction company, for inspection, according to photograph No. 21.
